TEST REPORT

C/221129I1

DEGREES OF PROTECTION PROVIDES BY ENCLOSURES (IP Code) according to UNE-EN 60529:2018 (IEC 60529:1989) and UNE-EN 60529:2018/A1:2018

Libelium One - One main node

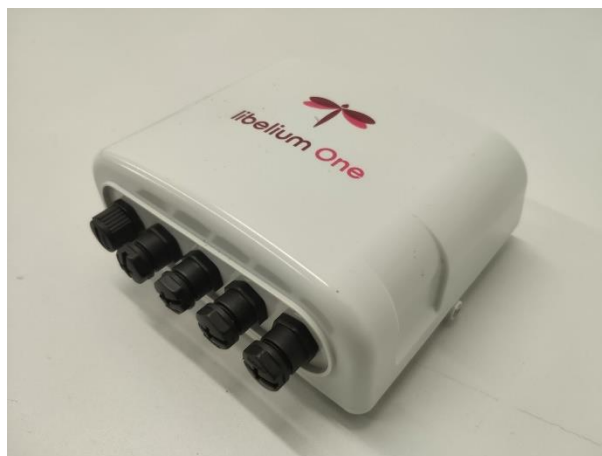
Sample type under test

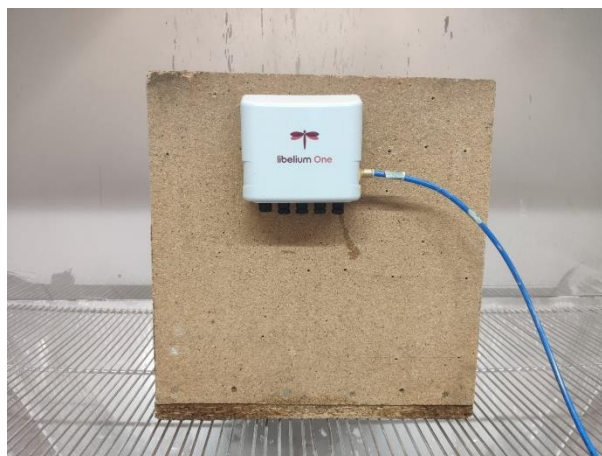
12	DEGREES OF PROTECTION AGAINST ACCES TO HAZARDOUS PARTS INDICATED BY THE FIRST CODE ELEMENT		P
	Protected against access to hazardous parts with a wire, degree of protection IP6X		P
	The access probe shall not penetrate. Access probe: 1 mm Ø, 100 mm length. Test force: 1 N ± 10%	The access probe does not penetrate into enclosure.	P
13	DEGREES OF PROTECTION AGAINST SOLID FOREIGN OBJECTS INDICATED BY THE FIRST CODE ELEMENT		P
13.4 & 13.6	Dust-tight, degree of protection IP6X		P
	Dust ingress shall not be allowed Category 1 enclosure. The enclosure is subjected to a maximum underpressure of 20 mbar. Exposure time: 8 hours.	The dust not ingress.	P

Supplementary information: Sample tested C/221129/4 #17

Sample before test

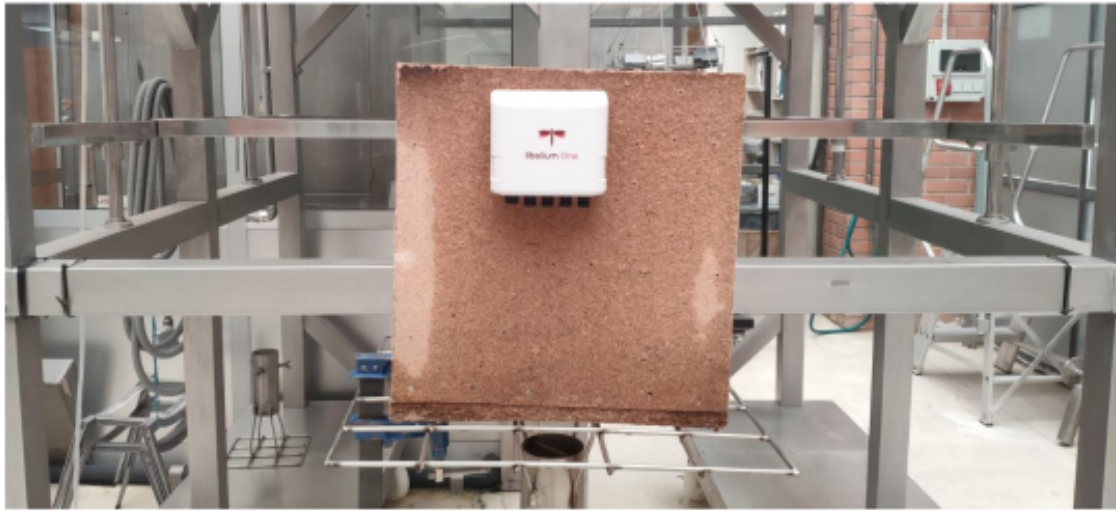
Clause	Requirement + Test	Result - Remark	Verdict
14	DEGREES OF PROTECTION AGAINST WATER INDICATED BY THE SECOND CODE ELEMENT		P
14.2 & 14.2.6	Protected against powerful water jets, degree of protection IPX6		P
	Water projected in powerful jets against the enclosure from any direction shall have no harmful effects. Internal diameter of the nozzle: 12.5 mm Delivery rate: 100 l/min \pm 5% Distance test nozzle-enclosure: 2.5 m to 3 m. Minimum test duration: 3 min	The water not ingress.	P

- be reached live parts or windings not designed to operate when wet.		P
	- be accumulated near the cable end or enter the cable if any.		P
	Dielectric strength test, if applicable. Application parts: Test voltage. (V):		N/A
	Enclosure provided with drain holes		N/A
Supplementary information: Sample tested C/221129/3 #18

Sample disposition

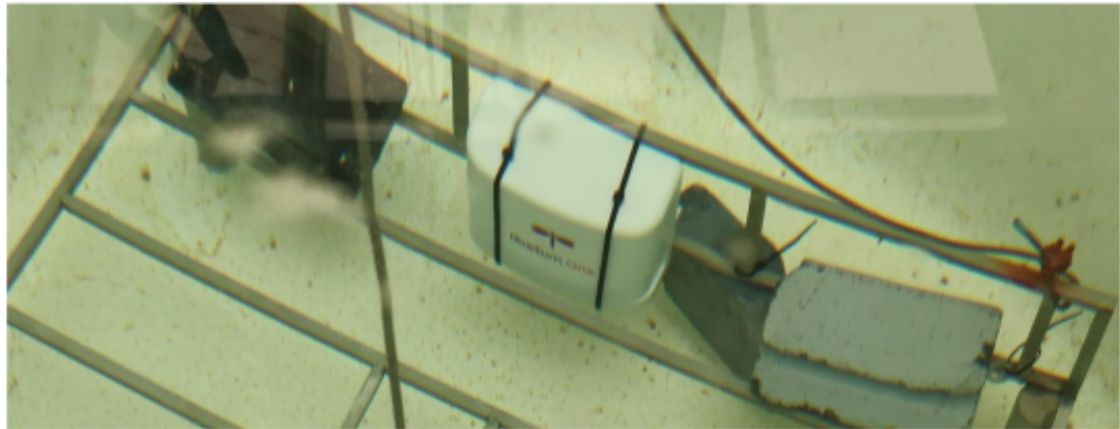
Clause	Requirement + Test	Result - Remark	Verdict
14	DEGREES OF PROTECTION AGAINST WATER INDICATED BY THE SECOND CODE ELEMENT		P
14.2 & 14.2.7	Protected against the effects of temporary immersion in water, degree of protection IPX7		P
	Ingress of water in quantities causing harmful effects shall not be possible when the enclosure is temporarily immersed in water under standardized conditions of pressure and time. Water-level on enclosure: 0.15 m above top 1 m above bottom. Exposure time: 30 min	The water not ingress.	P

- be reached live parts or windings not designed to operate when wet.		P
	- be accumulated near the cable end or enter the cable if any.		P
	Dielectric strength test, if applicable. Application parts: Test voltage. (V):		N/A
	Enclosure provided with drain holes		N/A
Supplementary information: Sample tested C/221129/2 #19

Sample during the test
